# United States Department of the Interior

## BUREAU OF LAND MANAGEMENT

Date: 10/01/09  
To: Minerals File UTU-70996  
From: Ted McDougall, Geologist  
Subject: Surface Management Site Inspection, Randolph Mining, Dusty Mine, UTU-70996 (E/037/0063), Monument Canyon, San Juan County, Utah.

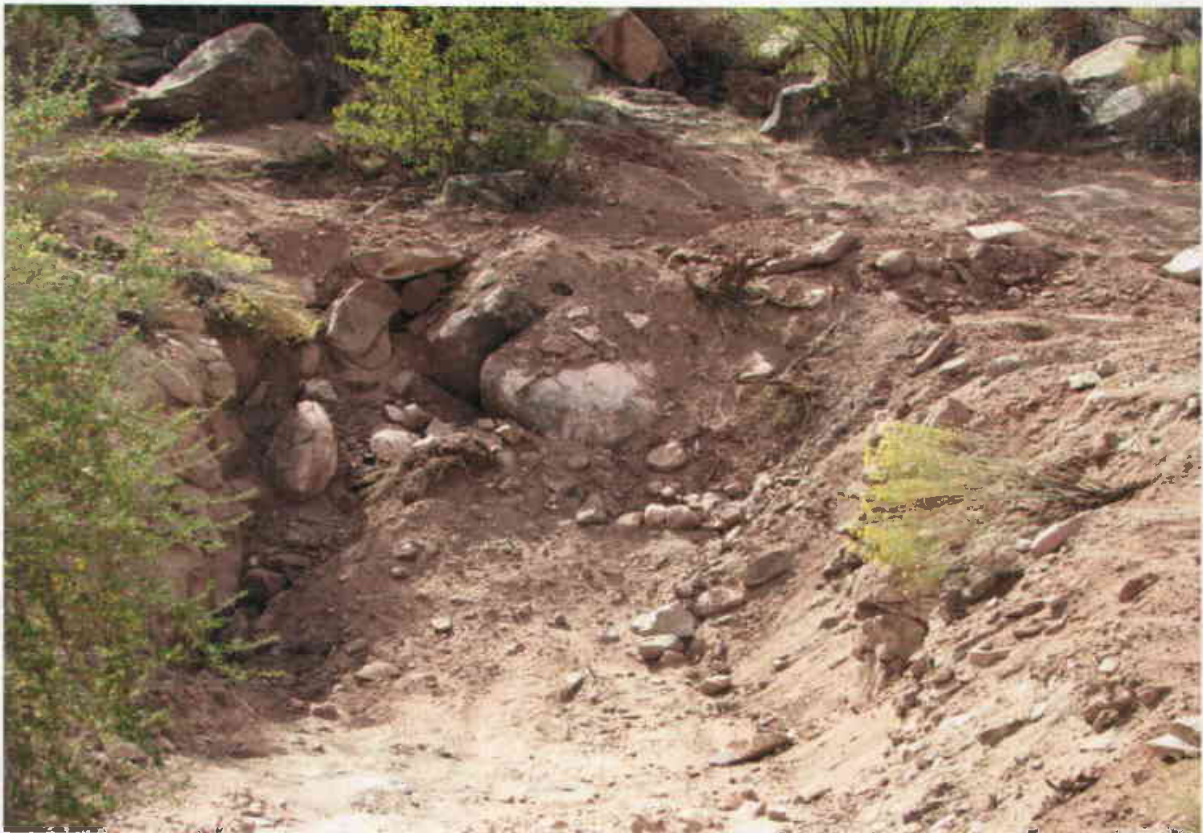
Work has recently been done at the site to seal the portal. Earthen material consisting of large boulders and finer soil and waste rock material has been placed into the portal using a skid loader. The decline trench has not been entirely filled. It is difficult to determine how far into the mine that the fill material was placed, but a comparison of previous photographs of the portal indicate that backfill material extends approximately 5-10 feet out from the portal. The fill material should serve as an effective seal provided that surface water does not collect in the decline trench and cause the portal to be exposed through settling. The operator has constructed a small diversion berm above the portal to help alleviate this potential.

Above: Fill material sealing the portal. Below: Small diversion berm to direct water away from portal.

In a telephone conversation, the operator said that the small disturbance had been seeded but I did not observe seed on the ground. However, it was a windy day and it had been blowing for a couple of days (gusts up to 40 miles/hr) so seeds likely had been covered and/or moved. The site should be checked next spring to monitor re-vegetation and ensure that the portal has not opened up.
